**HEET PRIMARY HEALTHCARE CENTER  
HEET, IRAQ**

**SUSTAINMENT ASSESSMENT**

**SIGIR PA-08-133  
JANUARY 23, 2009**

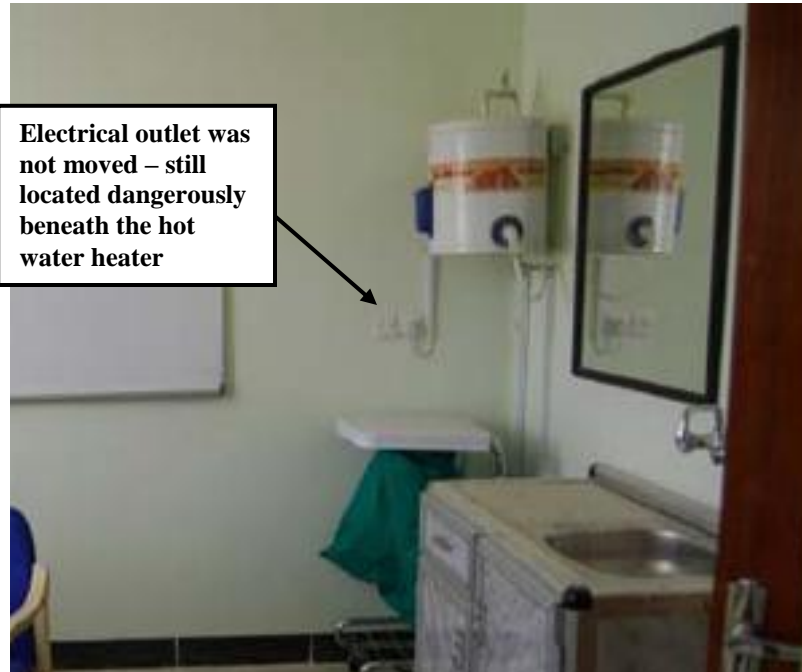
- flooring in the laboratory is a porous type, which is unacceptable for a PHC
- unapproved interior type fans have been installed on the exterior vents for the X-ray and laboratory roof vents
- several of the hot water heaters need to be moved away from electrical outlets
- hot water heaters were never approved, and appear to be old salvaged units
- in at least one instance, the contractor mounted a hot water heater above an electrical outlet (Site Photo 10)

**Site Photo 10. Location of hot water heater  
(Courtesy of GRC)**

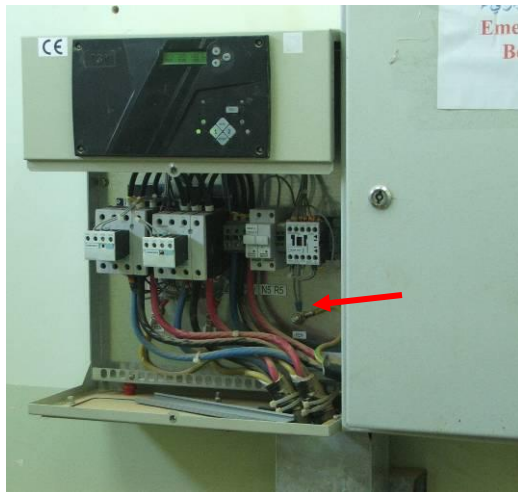
During the site visit, the 1-MW generator was supplying power for the facility. According to the administrator, this generator's automatic transfer switch does not work. SIGIR attempted to determine the cause of these problems by observing the control panel; however, the wiring and controls in the control panel were not easily understood. Due to time limitations on site, SIGIR could not identify the cause of the automatic transfer switch's malfunction (Site Photo 13). Now when power is lost from the national grid, a PHC representative has to manually switch on the generator.

**Site Photo 13. Access cover removed from non-functioning transfer switch**

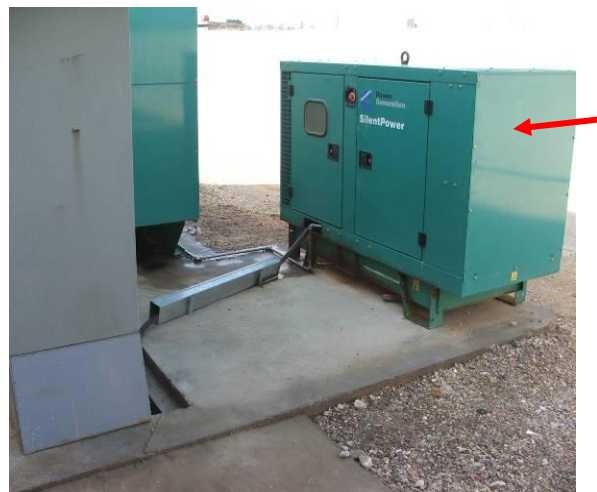
In addition, the administrator stated that the 500-kV backup generator does not work (Site Photo 14). The administrator stated that this has resulted in the southern half of the facility not having power.

**Site Photo 14. Secondary generator is not functioning according to administrator**

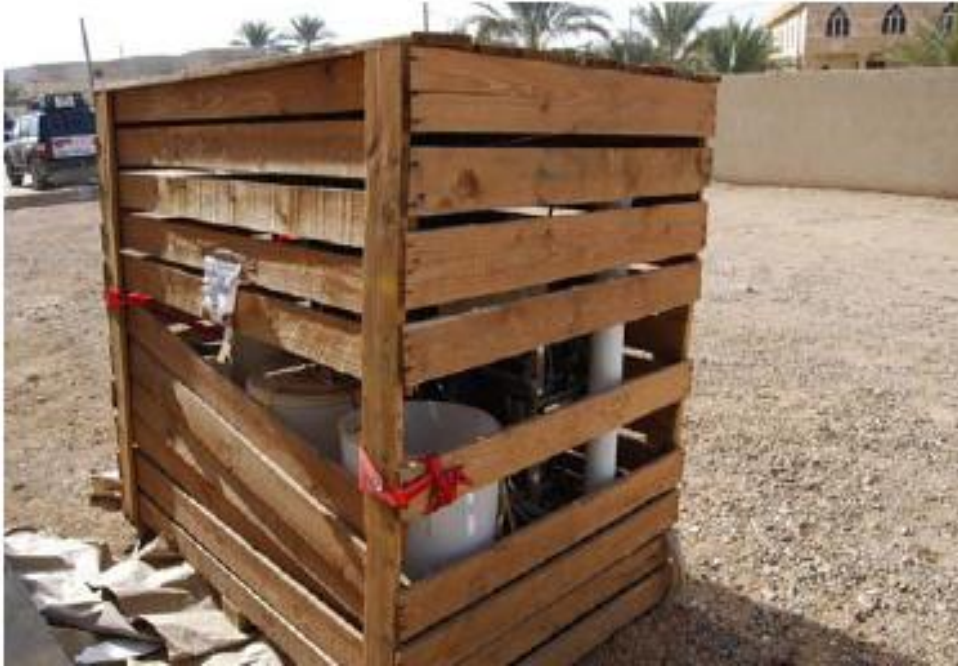
During our site visit, SIGIR observed that the RO unit had been delivered but not installed (Site Photo 15). According to GRD representatives, the contract required the contractor to install the RO unit; however, the RO unit is located behind the facility in exactly the same place where it was delivered in February 2008. Apparently, the RO unit had not been touched in over nine months. In addition, this equipment has been exposed

to the weather elements, such as extreme summer heat and sandstorms. The condition of the RO unit is unknown.

**Site Photo 15. During site visit, SIGIR identified the RO unit was located in the same place as when it was delivered in February 2008.**

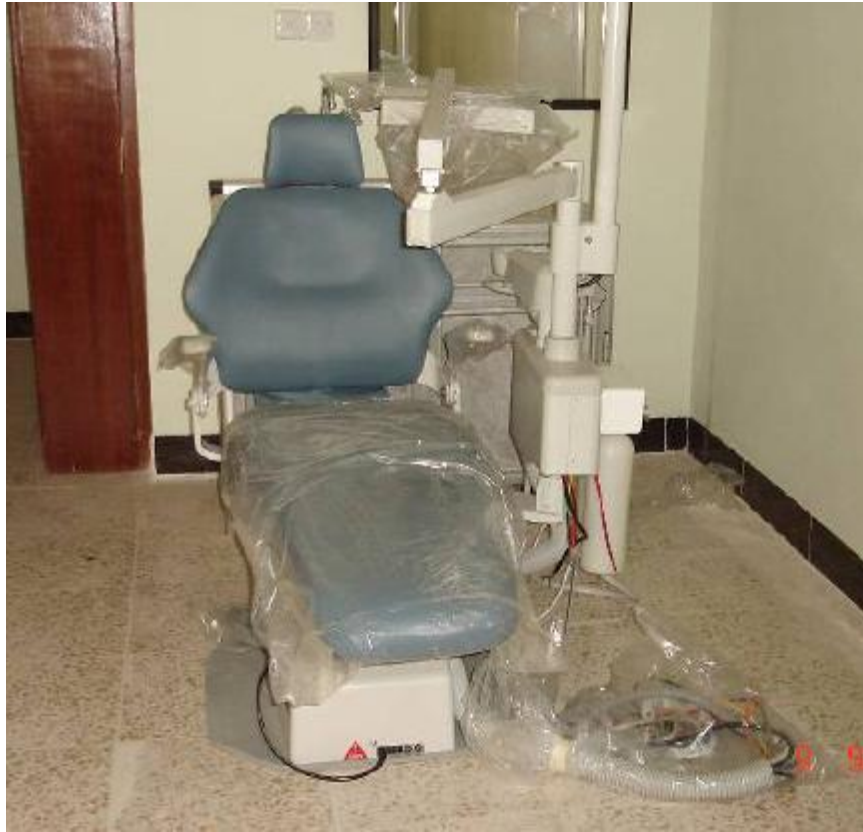
During the site visit, SIGIR observed the dental equipment, specifically one of the dental chairs was not installed and/or connected (Site Photo 16). According to a GRD representative, the "PVC [polyvinyl chloride] and Copper pipes for the dental room were missing so the dental chair was not completely installed." SIGIR noticed that the drain for the dental chair was not properly placed, which will require minor construction to move the drain to an appropriate place in the dentist's office.

The administrator stated the facility has a full time dentist; however, without any dental chairs properly installed and connected to purified water and drainage, there is little benefit the dentist can provide outside of very minor routine dental care. Also, one of the dental chairs, similar to the RO unit, appears to have been sitting in the same position for almost nine months.

**Site Photo 16. Delivered dental chair**

**Recommendations.** SIGIR recommends that the Commanding General, Gulf Region Division, perform all installation of, and training on, the medical equipment currently at the Heet PHC, according to its prioritization listing.

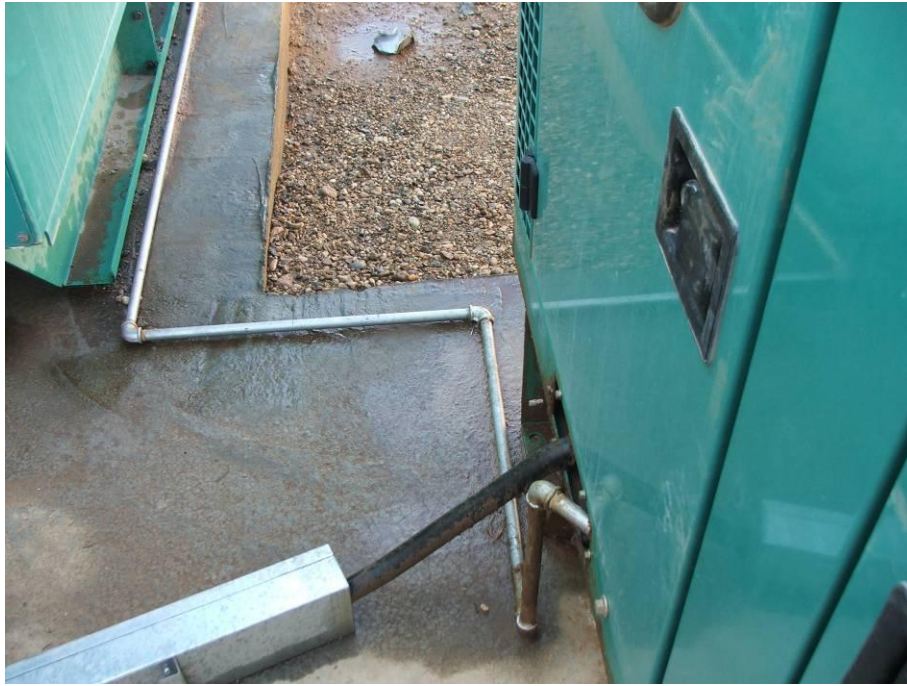
During the site visit, SIGIR noticed a strong smell of diesel fuel throughout the PHC. The source of the leak was one of the supply lines to the generator from the fuel storage tank (Site Photo 17). The diesel fuel was spreading to the main electrical line, which was not installed in a concrete vault (as required by a previous GRC inspection report). Since the generator and fuel tank were located adjacent to the building, the diesel fumes entered the building. The diesel fuel spill not only is a fire hazard, but due to the concentration of fumes throughout the facility, it is a potential respiratory health issue for the PHC staff and patients.

**Site Photo 17. Diesel fuel spill and electrical line not installed correctly.**

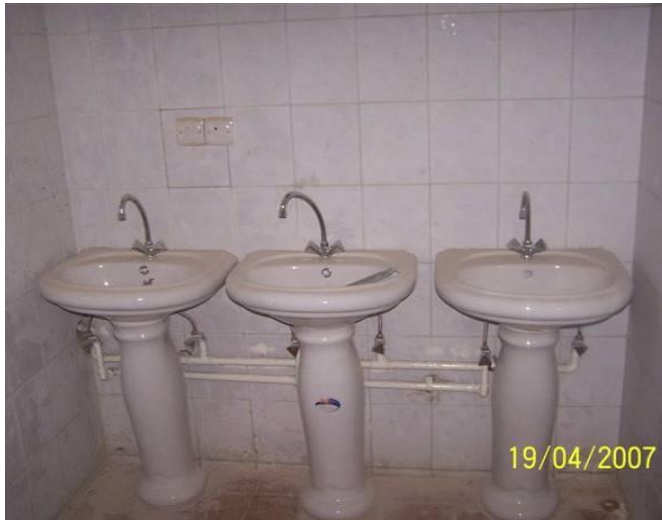
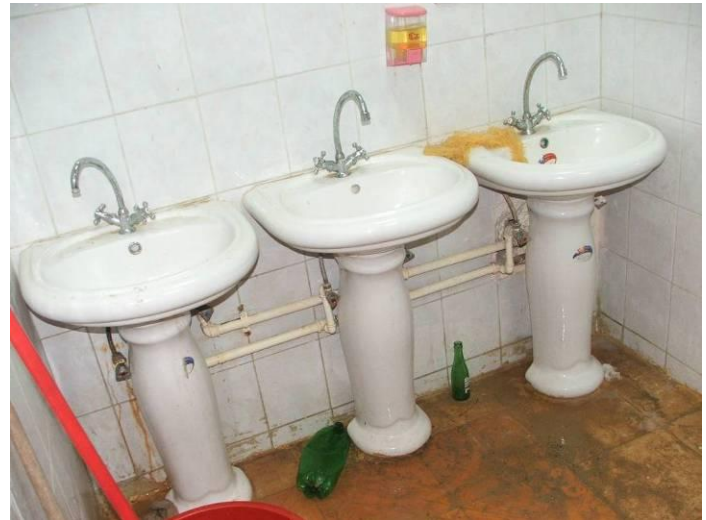
In April 2007, a GRC representative visited the Heet PHC and described the condition of the bathroom as “piping not to specification, damaged wall” and provided a photograph documenting the deficiencies (Site Photo 18). During the site visit, SIGIR inspected the bathroom and found that neither the piping nor the damaged wall had been corrected (Site Photo 19). In addition, the vanity had a water leak, which ran down the wall and on to the floor.

**Site Photos 18 and 19. Damaged restrooms (Courtesy of GRC)**

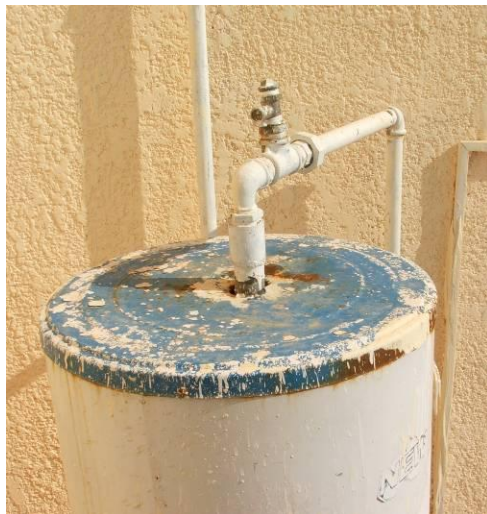
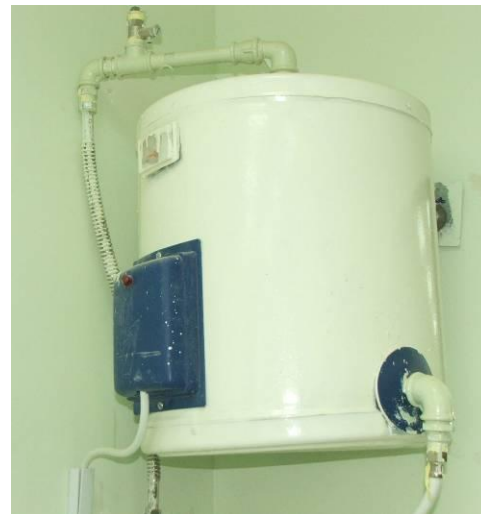
Further, the entire facility did not have access to hot water at the time of the inspection. SIGIR inspected the hot water heaters and determined they were of very poor quality. In most cases, the hot water heaters appeared to be used (it appears to have been repainted) and one large hot water heater was installed on the roof, which exposed it to the elements (Site Photo 20). In addition, the indoor hot water heaters were improperly installed, and in several cases, exposed the staff and patients to the potential of electrocution (Site Photo 21). The April 2007 GRC site visit identified used and poorly installed hot water heaters and SIGIR’s site visit 19 months later documented that the contractor had not corrected these issues.

**Site Photos 20 and 21. Non-functioning and possibly used hot water heaters**

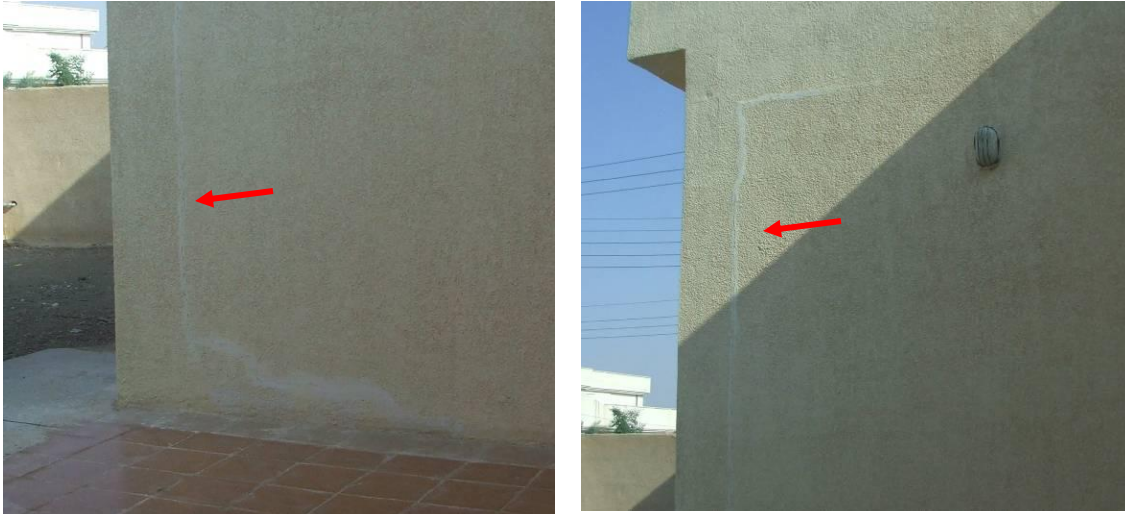
Due to security concerns, SIGIR was not allowed to tour the entire exterior of the facility; instead SIGIR could only quickly gauge the quality of work when entering/exiting the facility. SIGIR did observe cracking of the plaster along the exterior of the building (Site Photos 22 and 23). The cracks followed the location of the connections of the block in-fill to the reinforced concrete columns and beams. Although this is most likely not a serious structural problem, the cracking of the plaster can allow water to penetrate the facility and potentially cause water damage. Some of the cracks had been sealed with an unknown type of sealant that may need maintenance in the future. SIGIR also noticed several areas of water leakage in the interior of the building. Due to lack of time on site, it could not be determined if the water leakage was from the exterior cracking or other problems.

**Site Photos 22 and 23. Examples of exterior in-fill cracking**

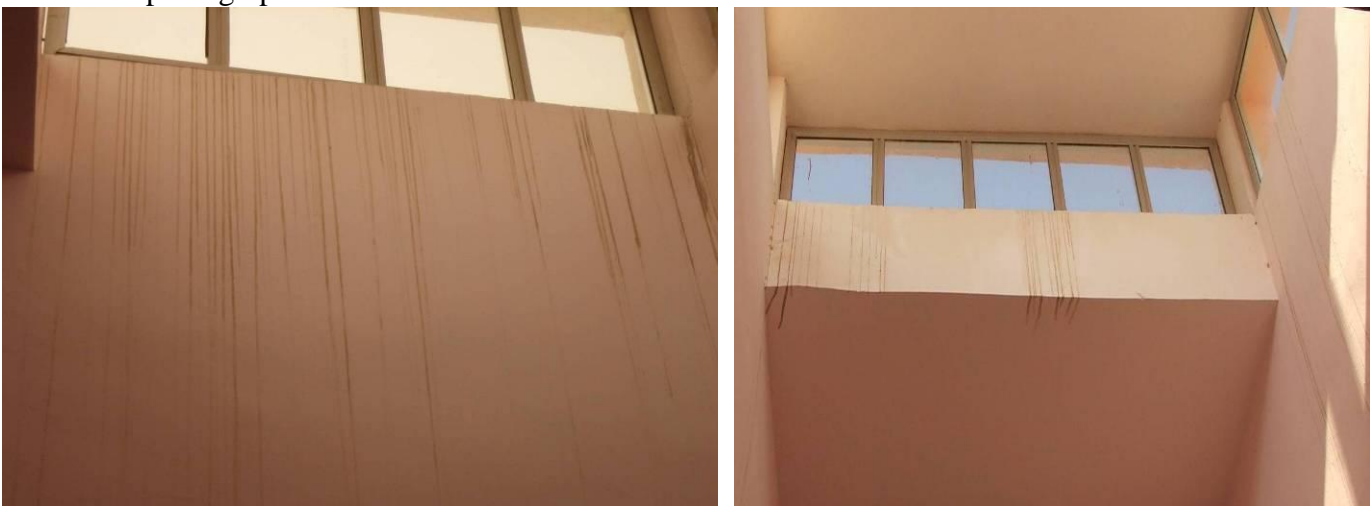
On the GRC's pre-final inspection interior leaks from the skylight were identified (Site Photos 24 and 25). Several days prior to the site visit, the city of Heet had experienced heavy rainfall. During the site visit, several leaks were observed on the interior walls throughout the facility. Specifically, the skylight contained interior leaks that were previously identified in the pre-final inspection. The turnover documentation stated all previously identified deficiencies from the pre-final inspection had been "completed;" however, the interior leaks illustrate the contractor had not corrected the deficiency. While time restraints limited SIGIR's ability to determine the exact cause(s) of the interior leaks, it appeared to be the result of exterior cracking, mastic roof sealants, and improper window seals.

**Site Photos 24 and 25. Interior leaks identified in pre-final inspection (left) and during SIGIR site visit (right)**

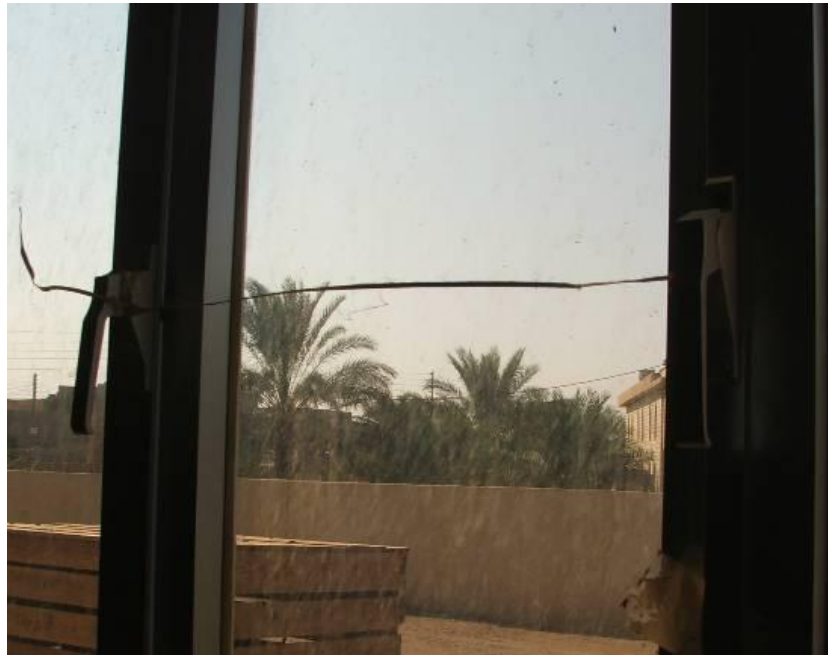
Even though the PHC has two security guards, the administrator was extremely concerned about the lack of security provided by the exterior windows. The administrator stated the windows are so poorly constructed and installed that in many cases, string was used to hold the windows “locked” together (Site Photo 26). SIGIR attempted to lock the windows without the use of the string, but found the window installed was of poor quality and would not lock.

**Site Photo 26. Poorly constructed and unsecured window.**

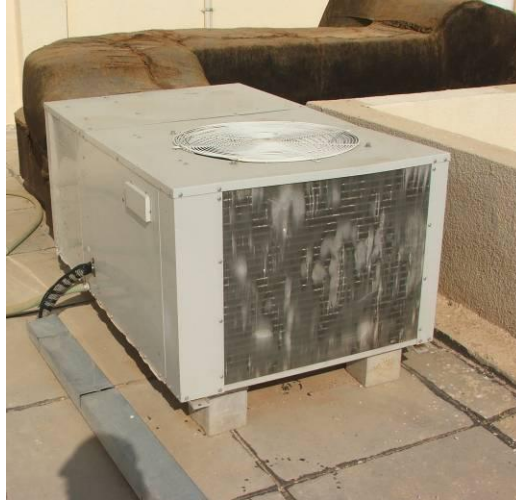
According to the administrator, the HVAC for the south end of the facility does not work. On the GRC’s pre-final inspection, damaged air conditioning units were identified as a deficiency. The turnover documentation stated all previously identified deficiencies from the pre-final inspection had been “completed.” SIGIR’s inspection of the non-operational HVAC unit found it damaged; however, it could not be determined if it was damaged when it arrived at the PHC or if it had been damaged since it was delivered (Site Photo 27). In addition, the facility has no electricity at the south end and it could not be determined if the non-functioning HVAC unit was actually broken or not working due to a lack of power. The HVAC drain line did not run to the edge of the roof (a deficiency noted in a previous GRC site inspection).

**Site Photo 27. HVAC unit non-functioning and damaged**
